Problems Encountered During the Recertification of the GLORY Solar Array Dual Axis Gimbal Drive Actuators

ABSTRACT

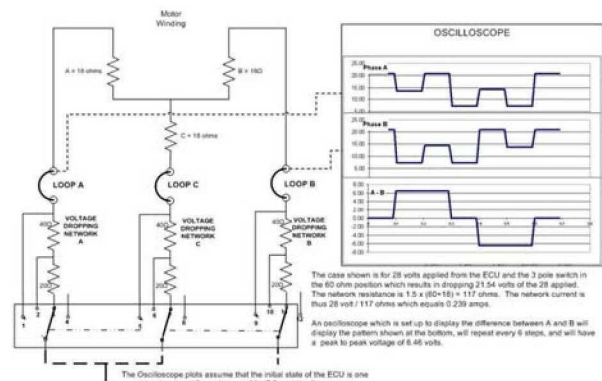
Figure 2 Threshold Voltage Testing

Fig. 2 shows the electronics interface test schematic, and the predicted oscilloscope plots. The test depended on being able to use the Glory flight Electronic Drive Unit (EDU) which has a normal input voltage range of 22 to 35 volts. Voltage can be reduced below 22 volts but internal power supply and control circuits require about 16 volts to function properly. This is much greater than the baseline 7 to 8 volts across the windings required to initiate and sustain movement of the actuators (i.e. threshold movement). For this reason the normal voltage range had to be furnished to the EDU and the external circuit dropping resistors shown in the

schematic were used to drop the output voltage across the windings. The fixturing for threshold voltage testing was such that both actuators were free to turn. Tab. 1 shows the threshold voltage test results. Inspection of these results shows that the new threshold voltage results were in-family with those recorded by Moog in 1999/2000. At this point it appeared testing would soon result in SADA re-certification for flight.

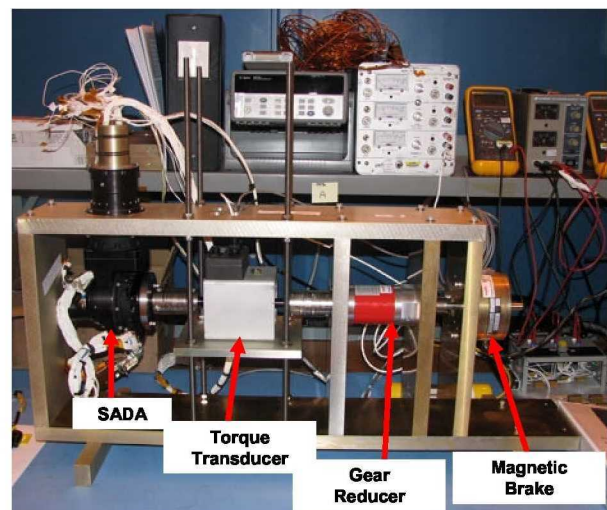
Figure 3 Torque Test Setup

Fig. 3 shows the setup for ambient torque testing at full flight driver voltages. The test arrangement included a Himmelstein torque transducer and a Planetrol gear reducer to amplify the effect of the Placid Industries hysteresis brake. Flexible couplings and careful alignment ensured there were no misalignment induced torque errors. The torque versus time plot of Fig. 4 shows a typical loss of synchronization (torque dropout). The simultaneously generated position versus time plot shows the same dropout. The objective was to find a brake induced torque resistance which the

Torque capability in the 150 in-lb to 190 in-lb (16.9 N-m to 21.5 N-m) range was produced prior to shipment but, as demonstrated by the plots in Fig. 4, there was either 30% degradation in torque or a serious flaw existed in the test apparatus. At least two days were spent checking the calibration of the torque test setup. The final test results for both SADAs are shown in Tab. 2. In this table, "N/A" indicates the configuration could not be tested without disassembly.

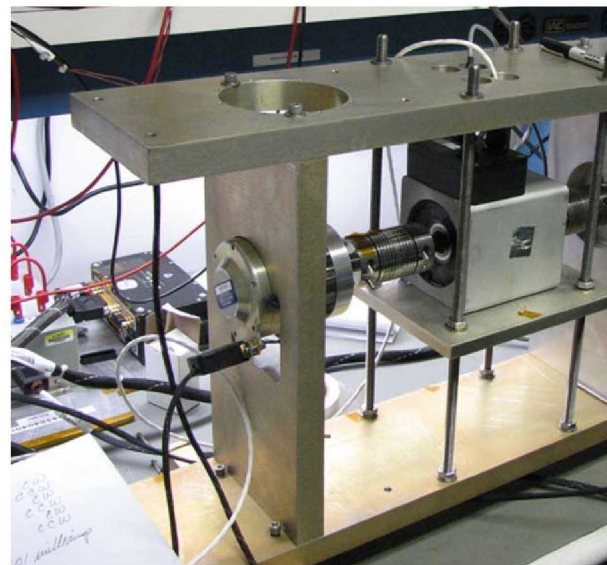
Figure 5 Moog Test Actuator Mounted in Altered Glory SADA Test Apparatus

using their test equipment but testing across the entire range of operation in the way Orbital had tested the SADAs. While this was accomplished at Moog, Orbital adapted their torque test setup to accept the Moog test actuator shown in Fig. 5. The Orbital torque results for the test actuator were in close agreement with those from Moog indicating approximately 30% torque loss and thus adding even more concern that the SADAs had, in fact, degraded over the past several years of storage and occasional use with Glory integration and test activities. The original test program was completed and an executive test summary written to document the results.

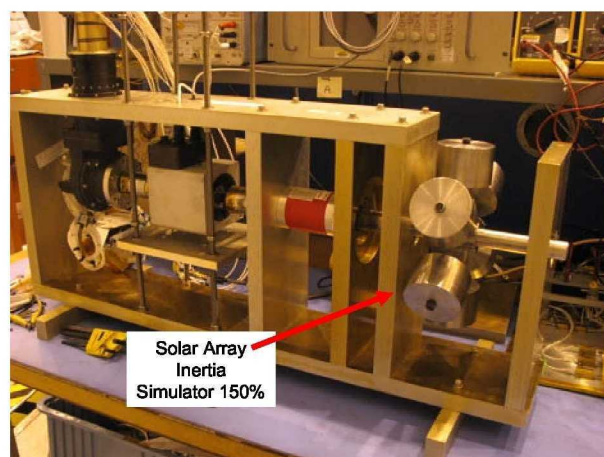
Figure 6 Inertia Testing Setup

The inertia used in this test setup was 150% of the solar array inertia that the Alpha actuator will be required to drive during each orbit. The inertia wheel consisted of 6 masses which could be positioned using threaded

spokes to adjust inertia. While the test increased confidence that the inertia can be started at 2°/second the amount of backlash in the test system precluded complete certainty of that conclusion. The majority of backlash was attributed to the test setup gear reducer and not in the SADA itself. The presence of backlash is non-conservative with respect to starting the inertia because more time is available for the momentum to increase which means the torque required from the actuator can be lower.

To achieve a more conservative, test the actuator speed was increased to 4°/second and then 6°/second. In all cases the inertia was started without any lost steps. Additional test were conducted with the backlash

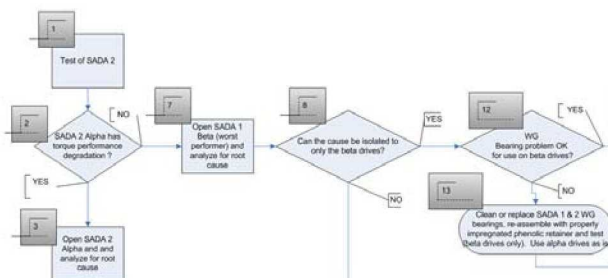
Figure 8 Initial Steps in a Detailed Test Strategy

The test services agreement with Moog was expanded to include return of the worst case SADA S/N 1 to Moog for testing followed by SADA S/N 2 if the torque findings continued to evidence degradation. This was a small part of a detailed test strategy, which is shown in Fig. 8.

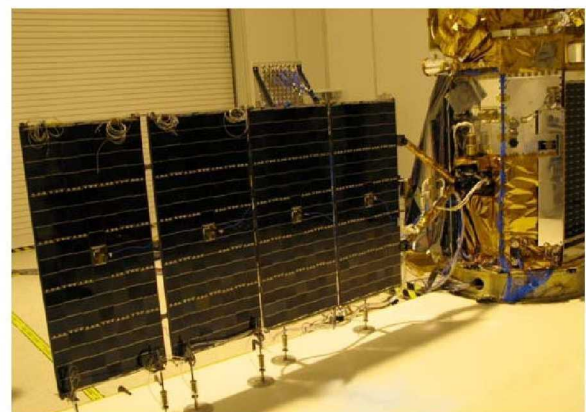
Figure 11 SADA Integrated onto Glory during Solar Array Deployment Testing

engineering team. The individual actuators were reassembled and subjected to a complete series of acceptance tests including two axes of vibration and two thermal vacuum cycles. The actuators were received at Orbital in early June 2008 and integrated onto the Glory observatory in early July. Fig. 11 shows the SADAs successfully integrated onto the Glory observatory during solar array deployment testing.

Based on the aforementioned findings, Orbital revised the Moog service agreement to include complete replacement of all harmonic drive bearings in both SADAs 1 & 2. While not contributing to the degradation the cotton phenolic wave generator bearing retainers were vacuum impregnated using an extended time of 3 days as recommended by the NASA
